LANDSLIDES AND RELATED FEATURES

OF THE SAINT ALBANS, W.VA. QUADRANGLE

GREGORY C. OHLMACHER

OPEN FILE MAP 83-80 (D-Z)

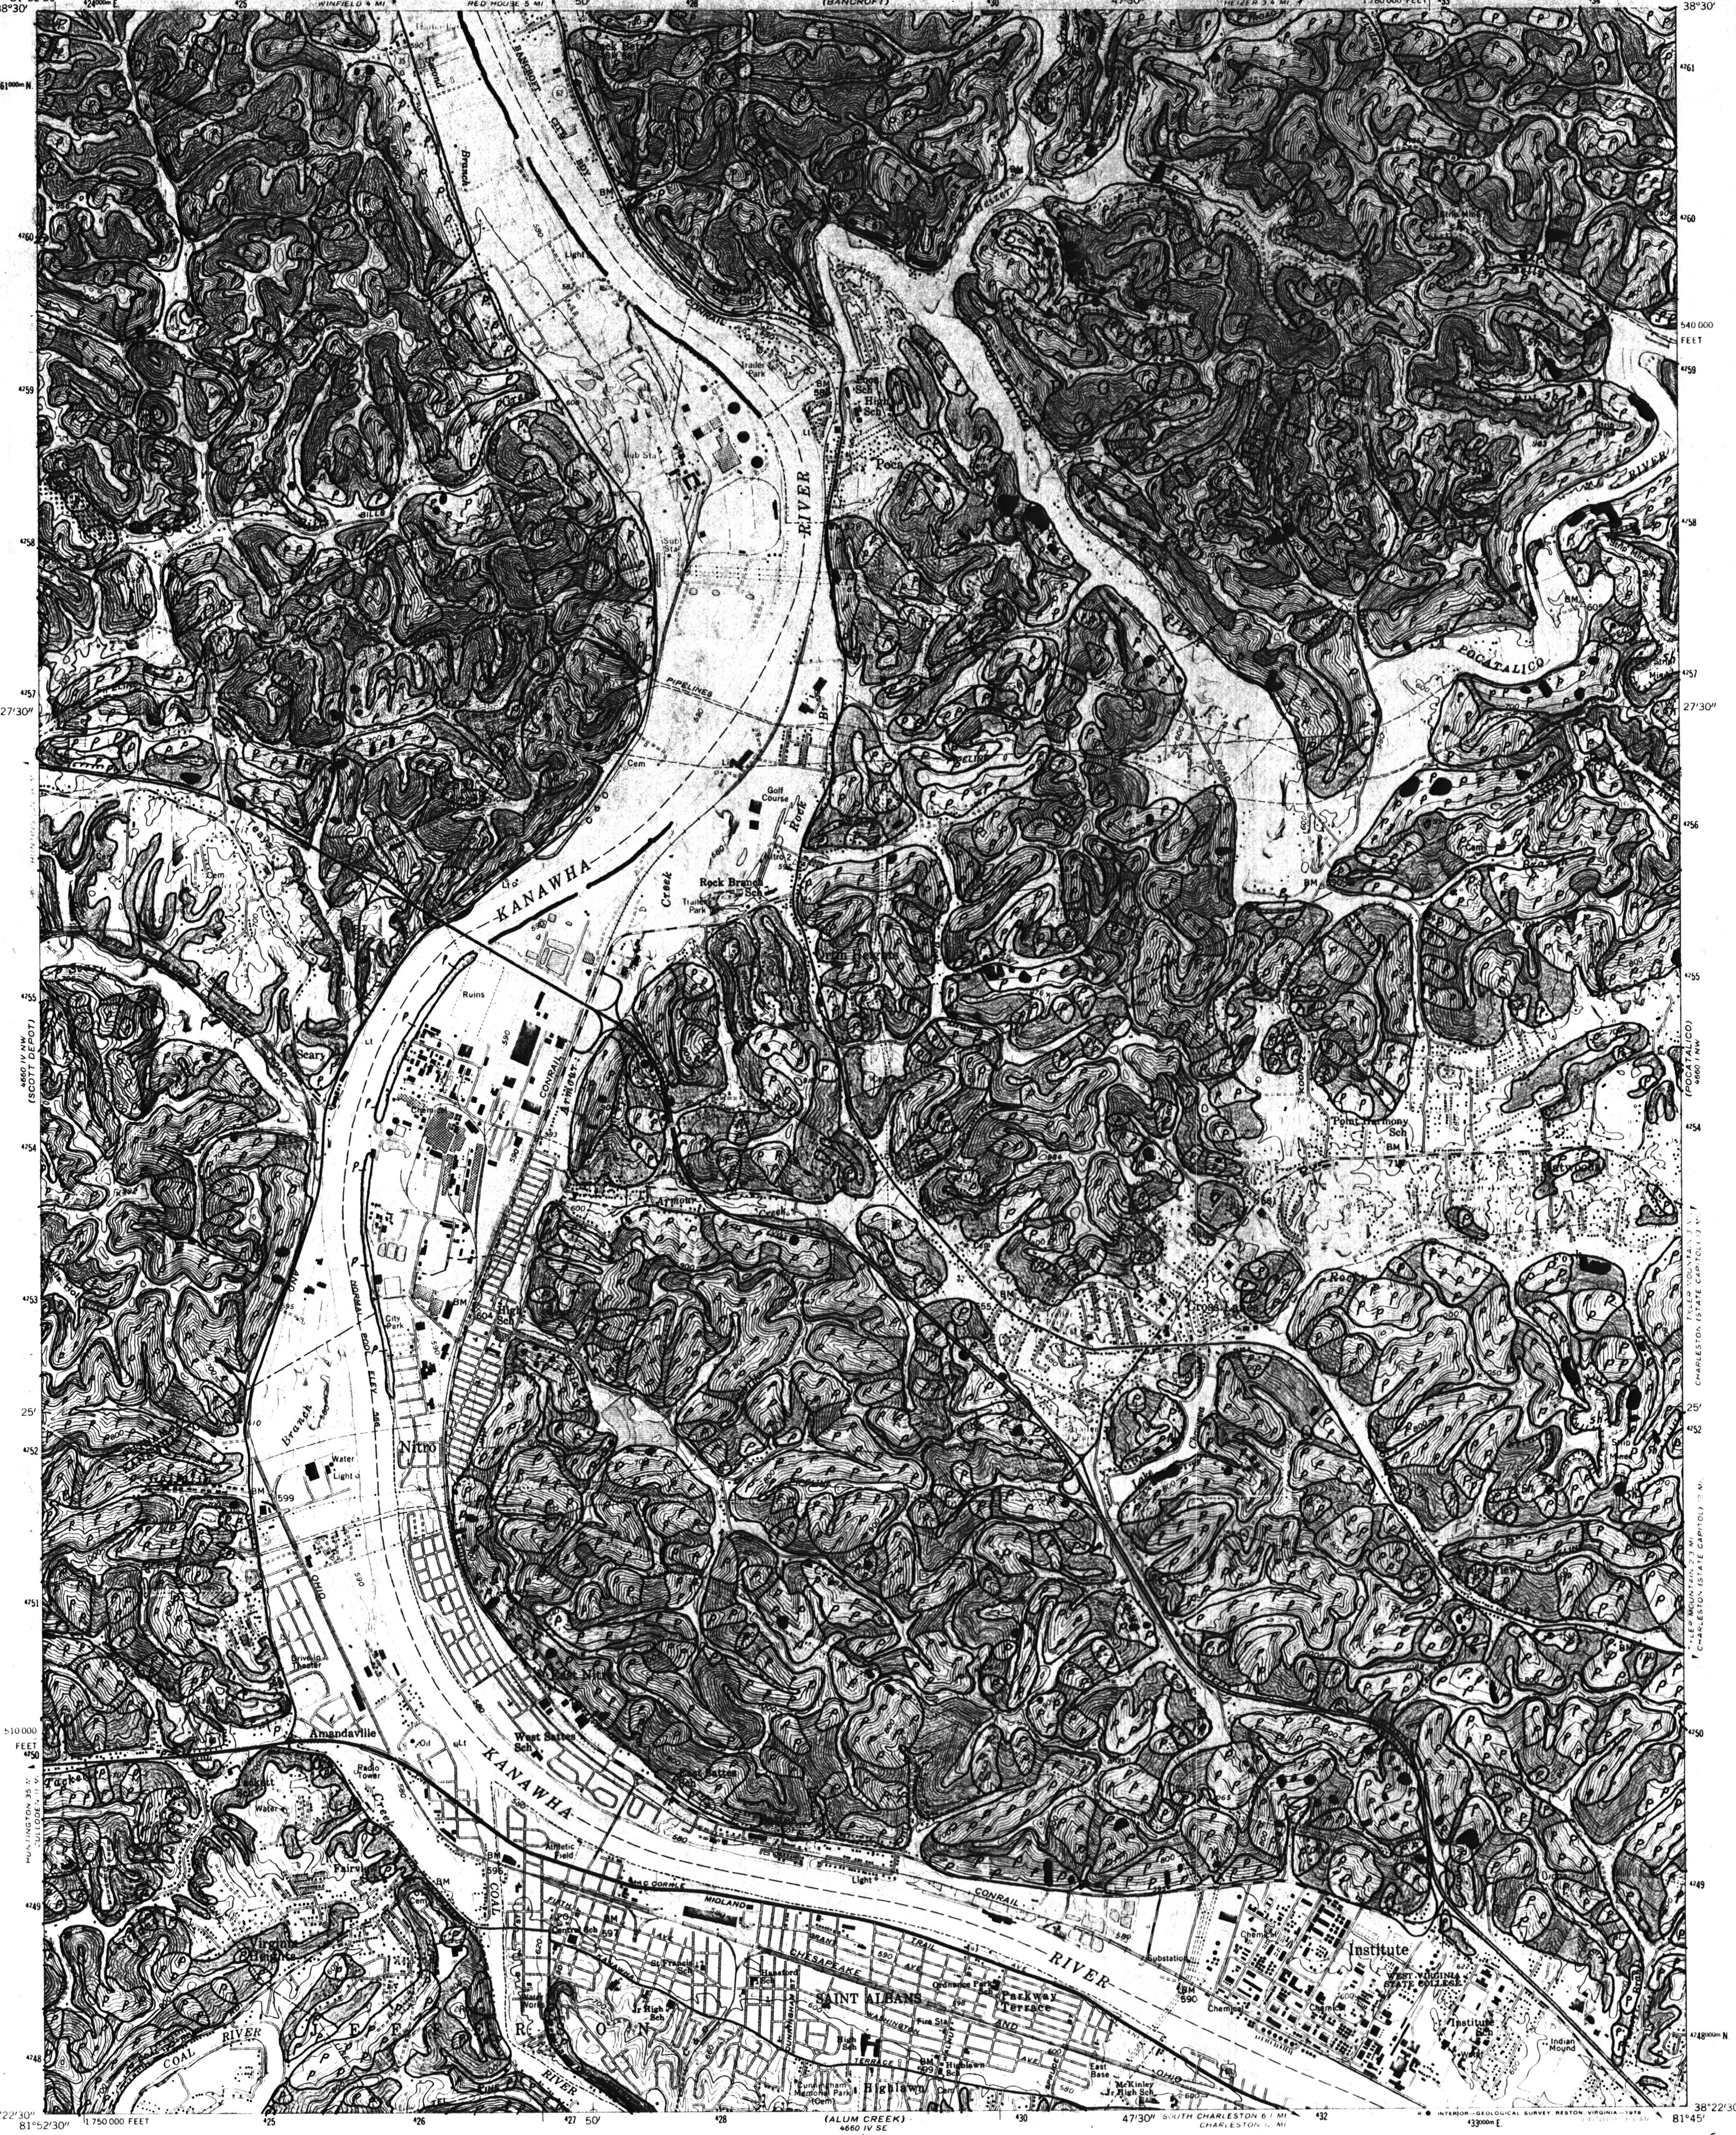
ACTIVE OR RECENTLY ACTIVE LANDSLIDE

Complex landslide composed of earthflow, debris slide, earth and rock slump. Identified from historical records, and from scars, debris and other field evidence. Ground extremely unstable, sliding accelerated by excavation, loading and changes in drainage conditions. May include areas with several active slides too small to be shown separately.

OLD LANDSLIDE

Area of extensive hummocky ground caused by earthflow and earth and rock slump. Lacks clear evidence of active sliding. Relatively stable in natural, undisturbed state, generally not affected by small structures properly sited in areas away from the edge of the toe; can be reactivated by extensive, rapid excavation, loading, and changes in ground water and surface water conditions. Area of old landslide probably includes recent ones not identified from field evidence or otherwise documented. Upslope boundary of landslide generally defined by modified scarp, but downslope (toe) may be gradational and not well defined.

COLLUVIAL SLOPE

Valley wall along major streams with slope as steep as 40° (85%); stony, clayey silt soil up to 50 ft. (15 m) thick; commonly buttressed by a terrace or bench at the toe of the slope; very susceptible to sliding by cutting of toe area, removal of terrace or bench, and overloading; slide commonly activated without apparent cause.

AREAS SUSCEPTIBLE TO DEBRIS FLOWS AND DEBRIS AVALANCHES

Primarily shallow, narrow ravines and chutes with accumulation of stony colluvium generally 10 ft. (3 m) or less in thickness, susceptible to rapid movement during intense rainfall. Most ravines and chutes designated show evidence of former debris flows and avalanches. Symbol 'a' designates historical debris flow or debris avalanche.

AREAS SUSCEPTIBLE TO ROCKFALL

Steep, locally vertical, natural and man-made slopes and cliffs, 15 ft. (4.5 m) or more high, formed dominantly of sandstone, limestone, sandy shale, mudstone and claystone. Interbedded mudstone, claystone and shale weather rapidly leaving sandstone and limestone rock faces unsupported.

SOIL AND ROCK SUSCEPTIBLE TO LANDSLIDING

Soil and rock similar to that involved in landslides elsewhere in map area; primarily areas associated with other rock types. Rock weathers rapidly on exposure forming clayey soil highly susceptible to sliding. Includes coves (U-shaped, shallow valleys) containing thick layers of clayey soil that are very susceptible to sliding where excavation breaks continuity of slope and where overloaded by artificial fill.

AREAS LEAST PRONE TO LANDSLIDES

Map areas in which no patterns or symbols are shown; primarily valley floors, ridge tops and broad benches; modification by excavation and fill may lead to local landslides.
